## Analysis of the Success Rate of Mine Reclamation at PT Mega Multi Energi, Teweh Baru District, North Barito Regency, Central Kalimantan Province

<sup>1, 2, 3, 4, 5</sup> Mining Engineering Study Program, Faculty of Engineering, Universitas Palangka Raya, Indonesia

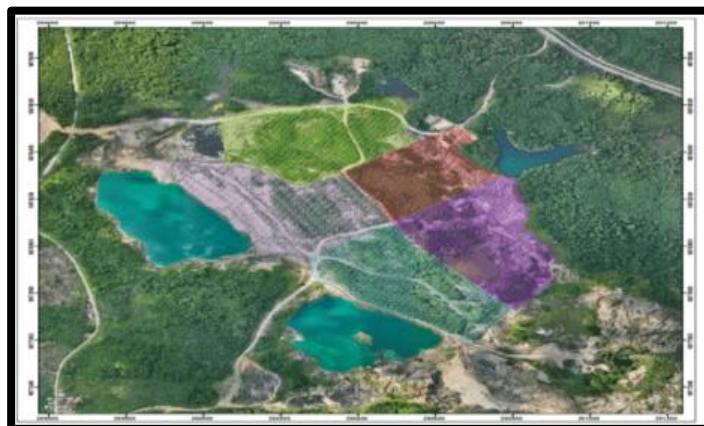
The reclamation work carried out by PT Mega Multi Energi covered 60.38 hectares, representing 85.79% of the planned total of 78.69 hectares. This discrepancy was due to the presence of unreclaimed areas, which included land use planning, revegetation and final completion. The reclamation area is shown in Figure 1 below:

**Figure 1.** PT Mega Multi Energi reclamation area for the period 2015 – 2019

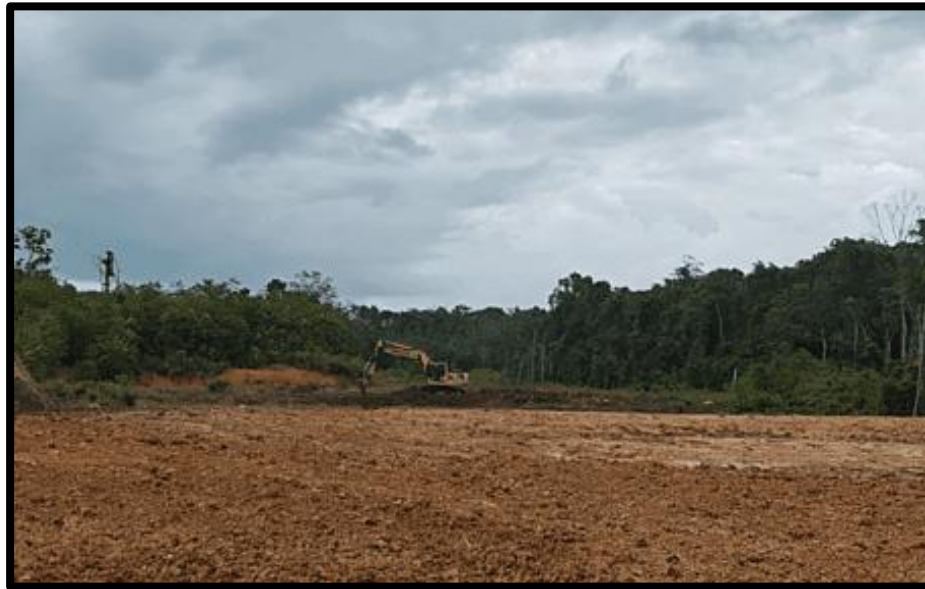
Topsoil was spread to a depth of 35-50 cm. However, the planned erosion control structures, such as check dams and drop structures, were not constructed on site, resulting in minor erosion in the land-reclamation area. This activity was carried out using the following equipment: one PC 400 excavator; two Hino 500 trucks. (PT Mega Multi Energi, 2019).

**Figure 2.** Land Reclamation

It is recommended that PT Mega Multi Energi prioritise the planting of cover crops to control erosion, optimise in-house seedling production at the nursery to meet planting targets, and expand the area covered by fertilisation. Furthermore, the use of remote sensing technology for regular monitoring is strongly recommended to track land degradation and canopy cover in real time.

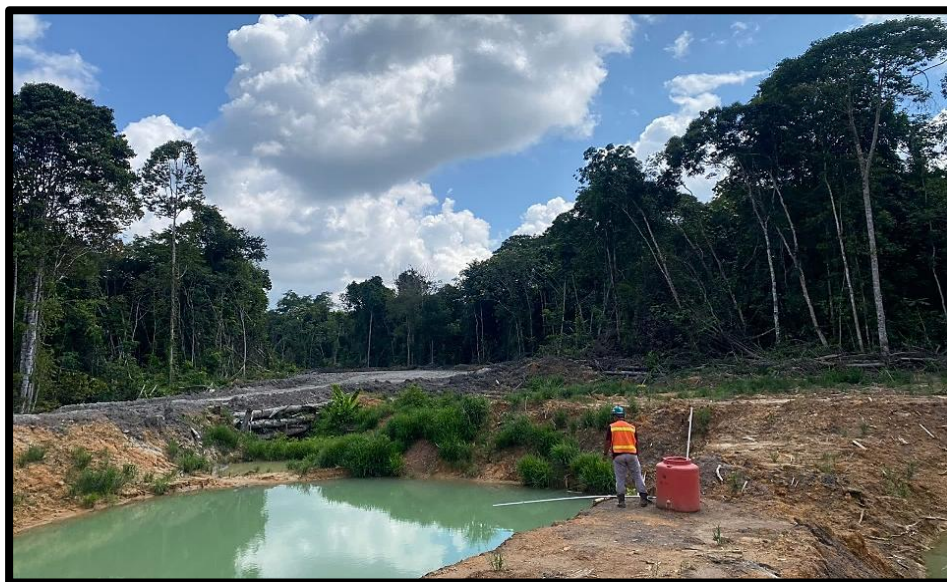
Acid mine drainage management was carried out using a neutralisation method involving the addition of quicklime and alum to the second and third settling ponds, ensuring that the water quality in the discharge pond leading to the river met environmental quality standards (pH 7.28).

**Figure 3.** Settling pond area
