## Geographic Information System (GIS)-Based Road Damage Mapping in Google Earth for Village Infrastructure Planning

<sup>1,2</sup> Department of Information Systems, Faculty of Science and Technology, Universitas Islam Raden Rahmat Malang, Jawa Timur

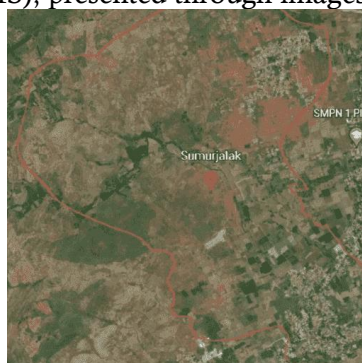
**Figure 3.** of Sumurjalak Village Point Determination Location (Step 1)

The implementation process of the Geographic Information System (GIS) on the Google Earth application is carried out by comprehensively creating node points on several roads that were not included in the repair budget in the previous year. The following are several stages in the image processing of road damage mapping from the Google Earth Geographic Information System (GIS), presented through images 3 to 12.

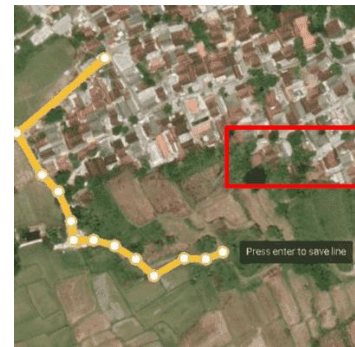
**Figure 6.** Drag and Drop Tombol Path and Polygon (Step 4)

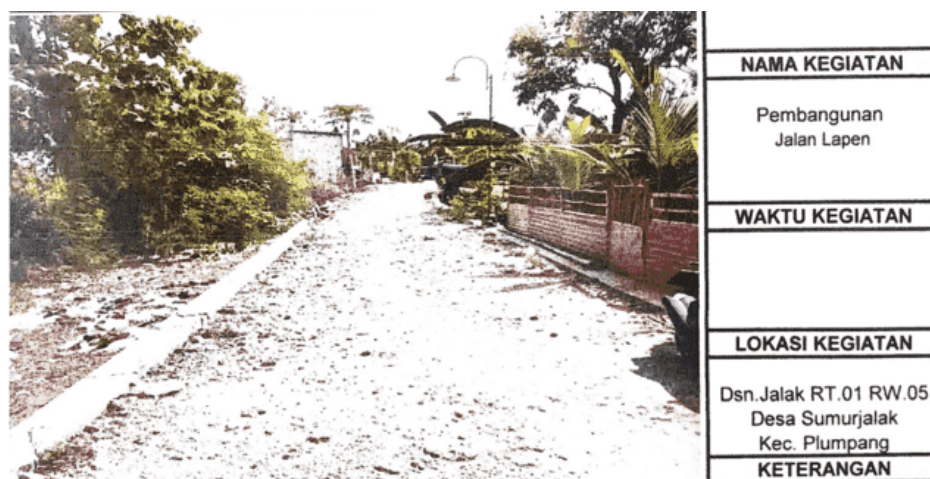
**Figure 14.** Field Survey as Dual Control  
**Source :** Budget Plan Document for Sumurjalak Village

After the identification process, a control process is carried out by government staff through direct on-site surveys. By utilizing mapping selection through the Geographic Information System (GIS) on the Google Earth application, the Sumurjalak Village Government can conduct mapping more efficiently and determine the priority scale for road repairs. The field survey implementation process is illustrated in Figure 14.

The field survey process is conducted to ensure the accuracy of digital data management results as an initial stage in the road repair process, which has been prioritized using the AHP diagram (Awaliani et al., 2024).
