## Root-Cause Investigation and Technical Reliability Analysis of the Starting-Air System Failure in a Marine Generator A Case Study of KM Sabuk Nusantara 101

| Article Information | ABSTRACT |
|---|---|
| <b>Article History</b><br><br><b>Received</b> : December 03, 2025<br><b>Revised</b> : December 25, 2025<br><b>Published</b> : January 10, 2026 | <p>The starting-air system of the 114-kW main generator aboard <i>KM Sabuk Nusantara 101</i> experienced repeated start failures during a 14-day sea operation, resulting in delayed engine activation and reliability reduction. This study aims to identify the root causes of the failure and evaluate the system's technical reliability performance. The investigation employed field observation, pressure measurement, functional testing, fault tracing, and logbook analysis, supported by Root-Cause Analysis (RCA) and reliability metrics (MTBF, MTTR, and failure rate). The results show three dominant failure sources: (1) air receiver leakage due to degraded flange seals, (2) solenoid valve contamination causing pilot pressure loss, and (3) starting-air valve seat wear leading to insufficient cylinder impulse pressure. Reliability calculation prod

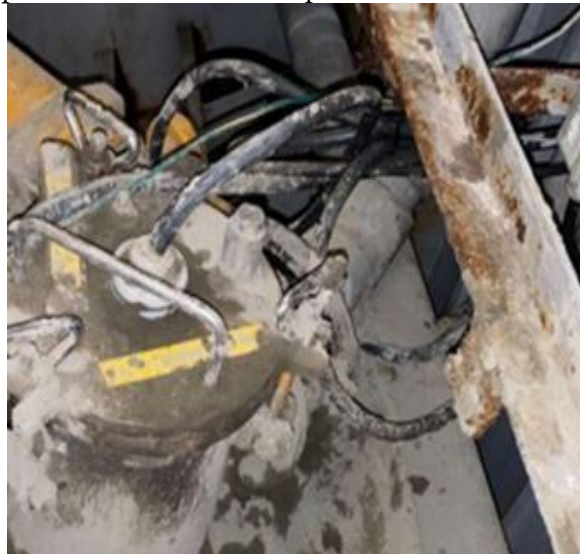
The pressure readings inside the air receiver dropped to approximately 50 psi from the nominal 100 psi, indicating a significant loss of stored air capacity. The soap-solution leak test showed visible bubbling at several flange joints and at the relief valve seat, confirming leakage in multiple points along the piping network. As a direct consequence, the system was unable to supply sufficient air volume to the cylinders, resulting in inadequate starting impulse and failure of the pilot lines to maintain control pressure. This condition caused the automatic distributor valves to malfunction and interrupt the sequence of the starting cycle, which explains the repeated failed start events recorded during operation. The leakage was traced back to degraded gasket materials, insufficiently tightened bolts, and relief valve seat wear, which are consistent with age-related deterioration and irregular preventive maintenance practices.

**Figure 2.** Pipe leak test confirming leakage points on flange and relief valve seat.

| Failure mode | Root cause(s) | Immediate corrective action (on board) | Medium-term remediation | Responsible |
|---|---|---|---|---|
| Air receiver leakage | Faulty flange seals, relief valve wear | Isolate & vent tank; soap test to locate leak; tighten/replace gasket; temporary clamp if needed. | Replace gaskets/bolts; test relief valve; schedule NDT for receiver if corrosion suspected. | Chief engineer / maintenance crew |

After identifying the source of the pneumatic malfunction, several corrective actions were carried out on board and subsequently validated through post-repair functional testing. The first corrective step involved leak sealing and retesting using a soap-solution inspection, which confirmed that receiver pressure began to recover toward its nominal level after gasket replacement and bolt tightening. This improvement restored the stored charge capacity needed for initial air delivery. The second action focused on solenoid system recovery, where the spool was cleaned and, where necessary, replaced to eliminate contamination deposits that had restricted its movement. As a result, the pilot pressure increased to operational levels, allowing the automatic sequence to resume normally during start attempts. Finally, valve lapping and seal replacement were performed on the cylinder starting-air valves to correct seat leakage; this intervention successfully restored impulse pressure delivery to the cylinders and ensured that torque was sufficient to rotate the crankshaft during starting. These combined actions produced measurable
